Engineering Assessment of Big House at Summit Station, Greenland

Final Report

Lynette A. Barna, Keran J. Claffey, James S. Buska,
and Jennifer L. Mercer

April 2011

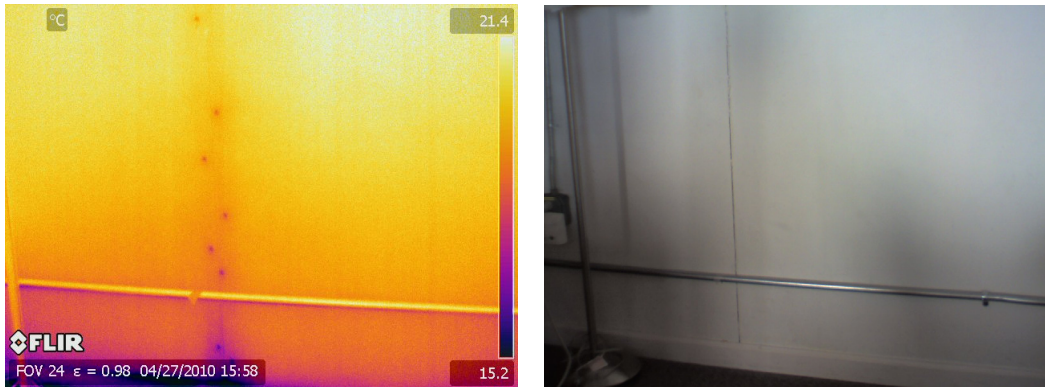
Significant impacts from the periodic lifting of the building were not observed in the IR imagery. As an example, separation between seams in abutting structural insulated panels (SIP) in the walls was minor. A typical

seam is shown in Figure S-2. The IR and visual images are of the north interior wall in the dining area.

Figure S-2. Vertical seam between SIPs does not show separation (north interior wall in dining area).

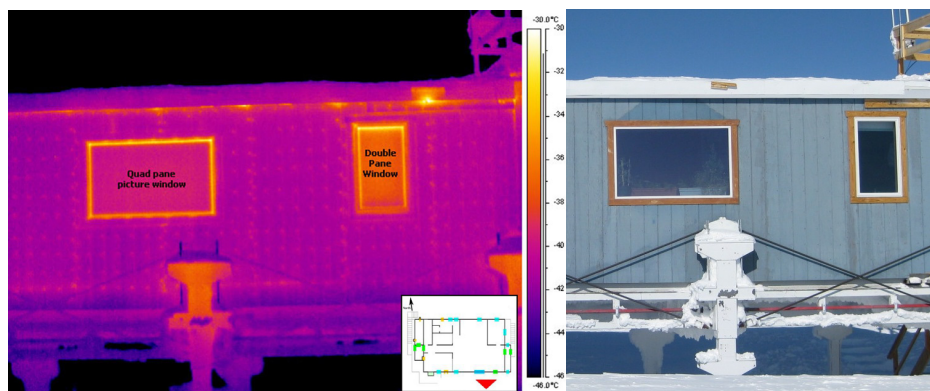
The exterior IR imagery of the double-paned windows showed more heat loss than found for the quad-pane window. This is seen in the IR imagery in Figure S-3, showing the southern exterior side of the building. A well sealed opening during the installation of higher quality windows maximizes the anticipated energy savings. In addition, installing and sealing the window opening are important so as not to compromise the energy savings from the higher quality window.

Figure S-3. Quad-pane window reduces heat loss compared to a double-pane window (exterior south side).

- Replace the remaining double-paned windows with triple-paned windows. This will improve the energy efficiency. This task has been identified and planned by CPS for improvement.

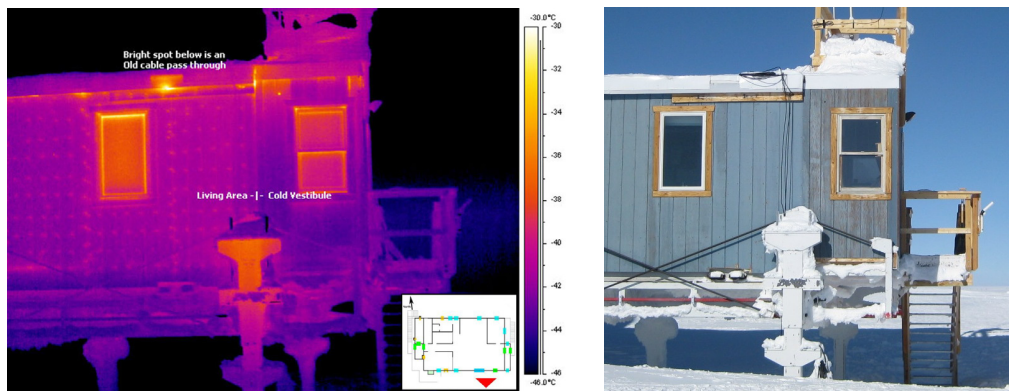
The access hatch to the roof penetrating the ceiling in the unheated east vestibule is a source for heat loss and creates a buildup of frost along the interior of the opening. Heat sources are the shared wall with the main room, and the sunlight that comes through the southern window.

Similarly, more heat loss was observed along the south side fascia, particularly toward the eastern end of the building, where instruments had previously been installed and in locations where repairs had been made to the metal flashing. Figure S-4 illustrates the heat loss observed in the IR imagery from the south side eastern end of the building. The cable pass-through to the radome (Fig. S-5) is an example where the cable pass-through is well insulated and little heat loss occurs.

Figure S-4. Difference in thermal envelopes between heated main room and unheated east vestibule, and heat loss along fascia (exterior south side).

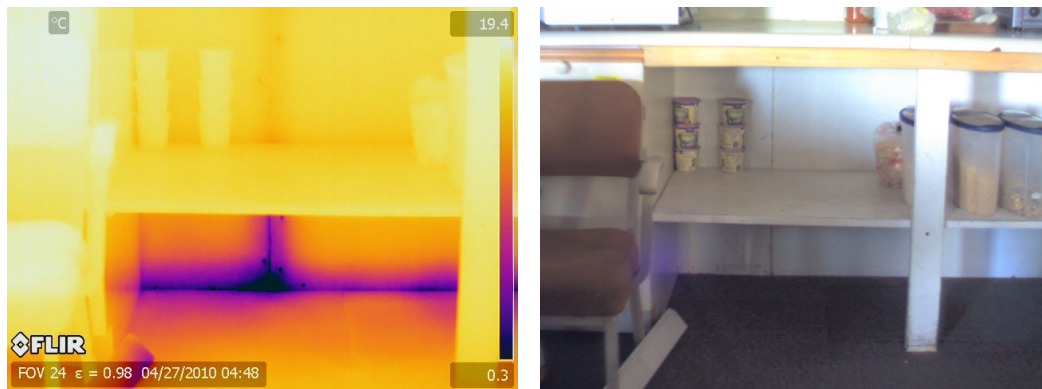
On the main floor, where the wall is joined to the deck, several areas were identified. Locations that appeared to have more heat loss included a cold spot under the counters in the main room, as shown in Figure S-6 (which was immediately caulked), an area in the northeastern corner of the office (which may not be noticeable owing to storage under the desk), and a location in the bathroom along the baseboard where frost had developed.

Figure S-6. Cold spot under the counter in the south wall of the main room.

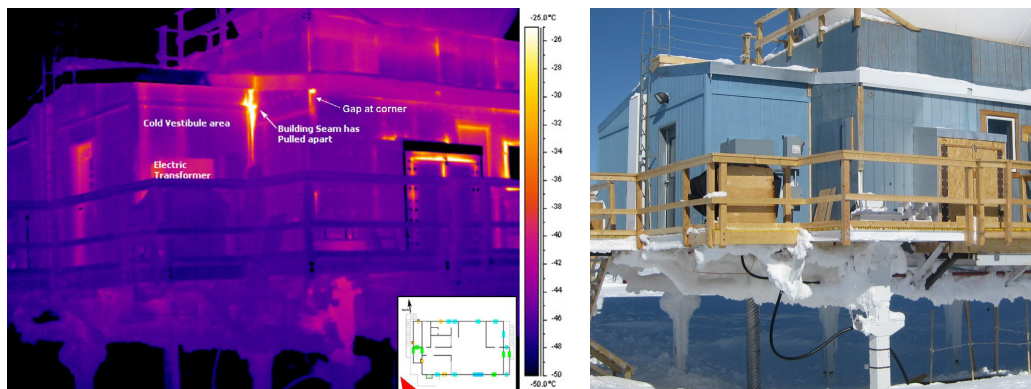
Very high heat loss was observed at the southwestern corner of the structure where the west vestibule connects to the main building (Fig. S-7). This location was identified and noted for repair when the penetration survey was conducted by CPS.

Figure S-7. Excessive heat loss at a gap located in the southwestern corner.

- Repair the two gaps on the southwestern side of the building, at the interface where the west vestibule connects to the main building and the gap at the southwestern corner.

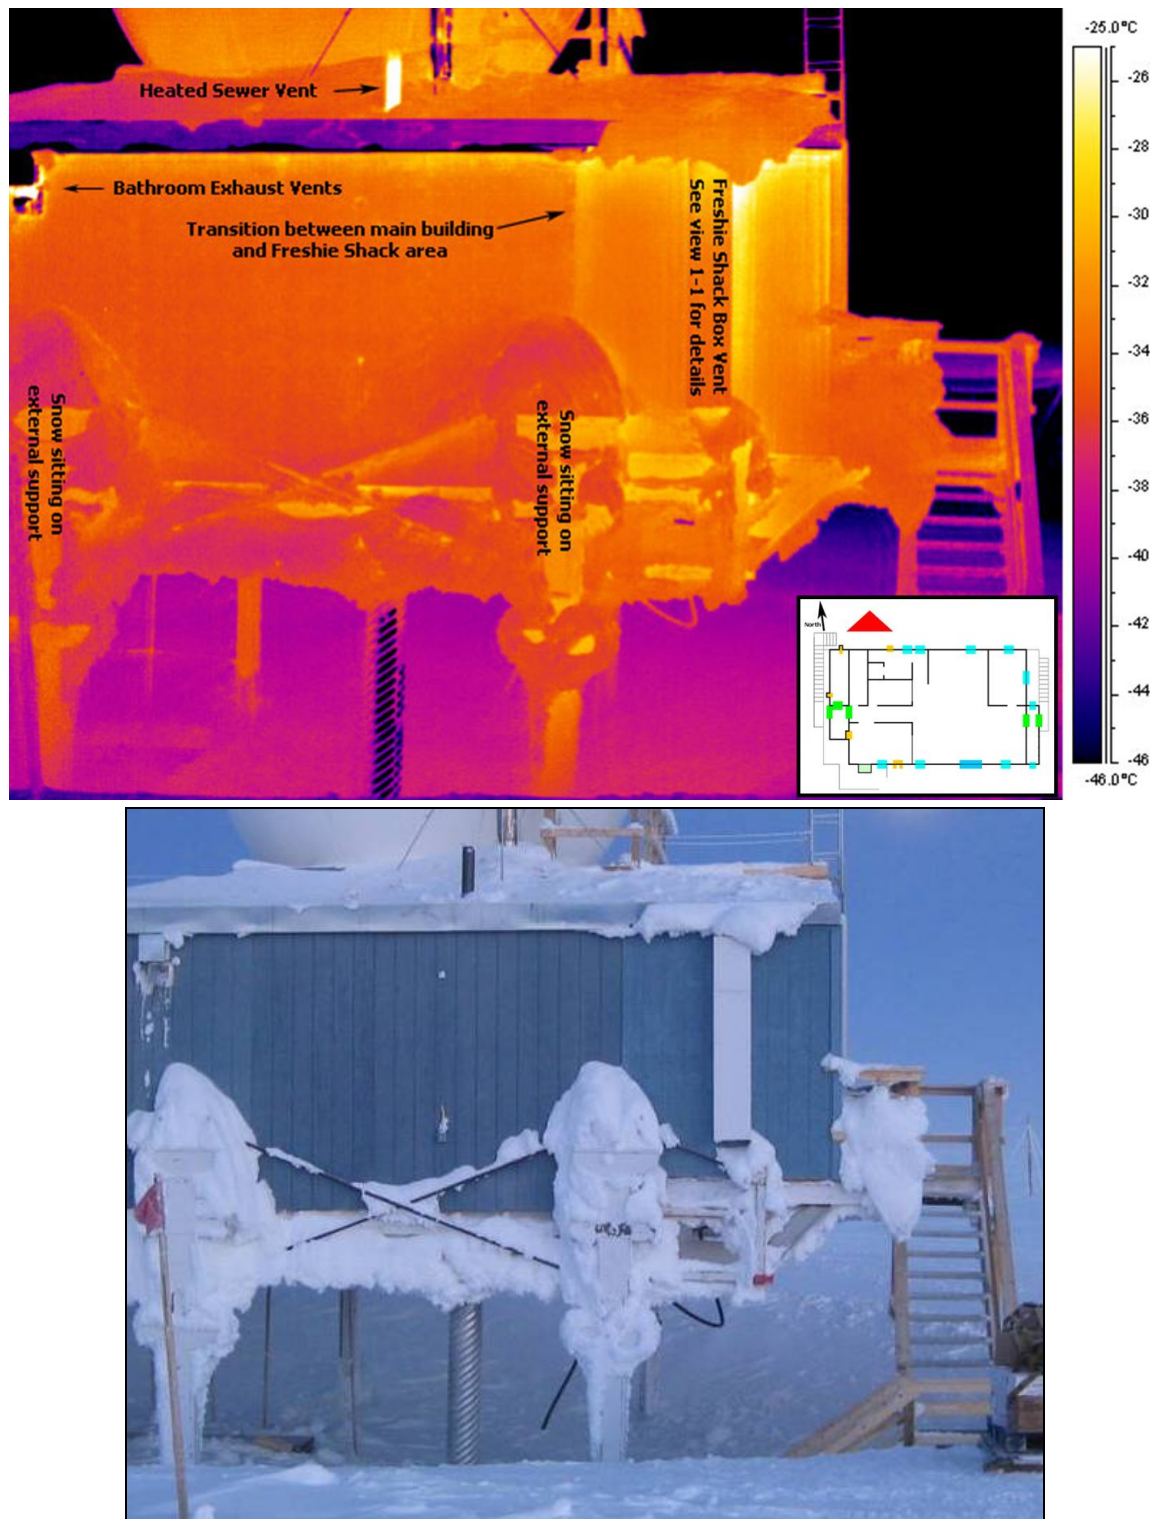
Beginning on the north side western end of the Big House, **View 1** (Fig. 14) includes the exterior wall of the mechanical room, freshie shack, and access stairway of the west entrance. The west vestibule (with dimensions of 2 m wide \times 6.8 m long) was added to the main structure in 2006 (CPS and NSF 2009). There is a slight amount of frost buildup at the bottom of the fresh air vent to the freshie shack. The bright spot on the roof is the heated vent pipe for the sewer in the mechanical room. The transition between the original construction and the freshie shack shows some heat loss at the common wall between them. The bright area along both the sides and bottom of the fresh air vent indicates heat loss out of the freshie shack, although the vent on the inside was covered with cardboard. The freshie shack consists of a 100-mm SIP, covered with an interior metal skin commonly used for food storage. The exterior of the west vestibule is 12.5-mm T-111 siding and, on the north side of the building, is aligned flush with the existing T-111 siding.

Figure 14. View 1 showing location (inset), thermal, and visual image of the exterior North side West end.

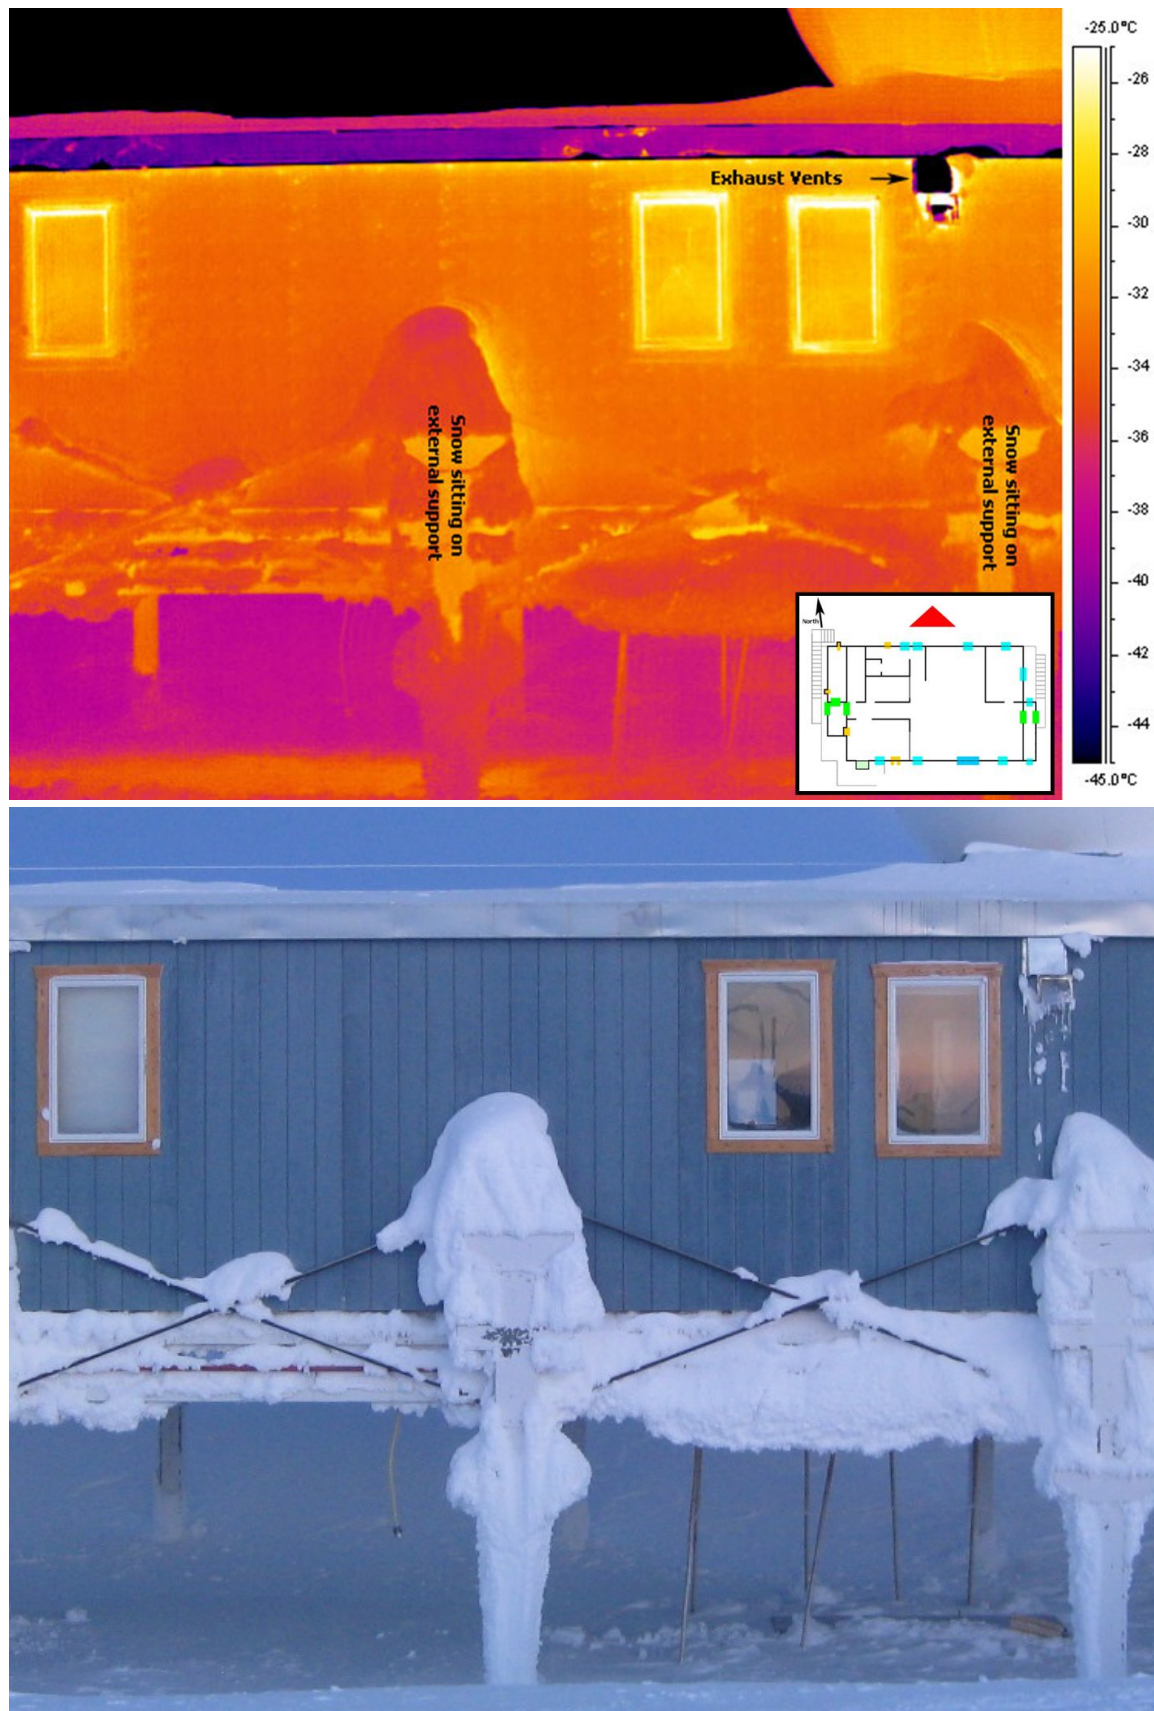
The set of images in Figure 15 are from **View 2** in the mid-section of the north exterior wall. The main room window is on the far left and the windows to the right are those in the hallway and laundry room/bathroom.

Figure 15. View 2 showing location (inset), thermal, and visual image of the mid-North exterior wall in the vicinity of the laundry room and main room.

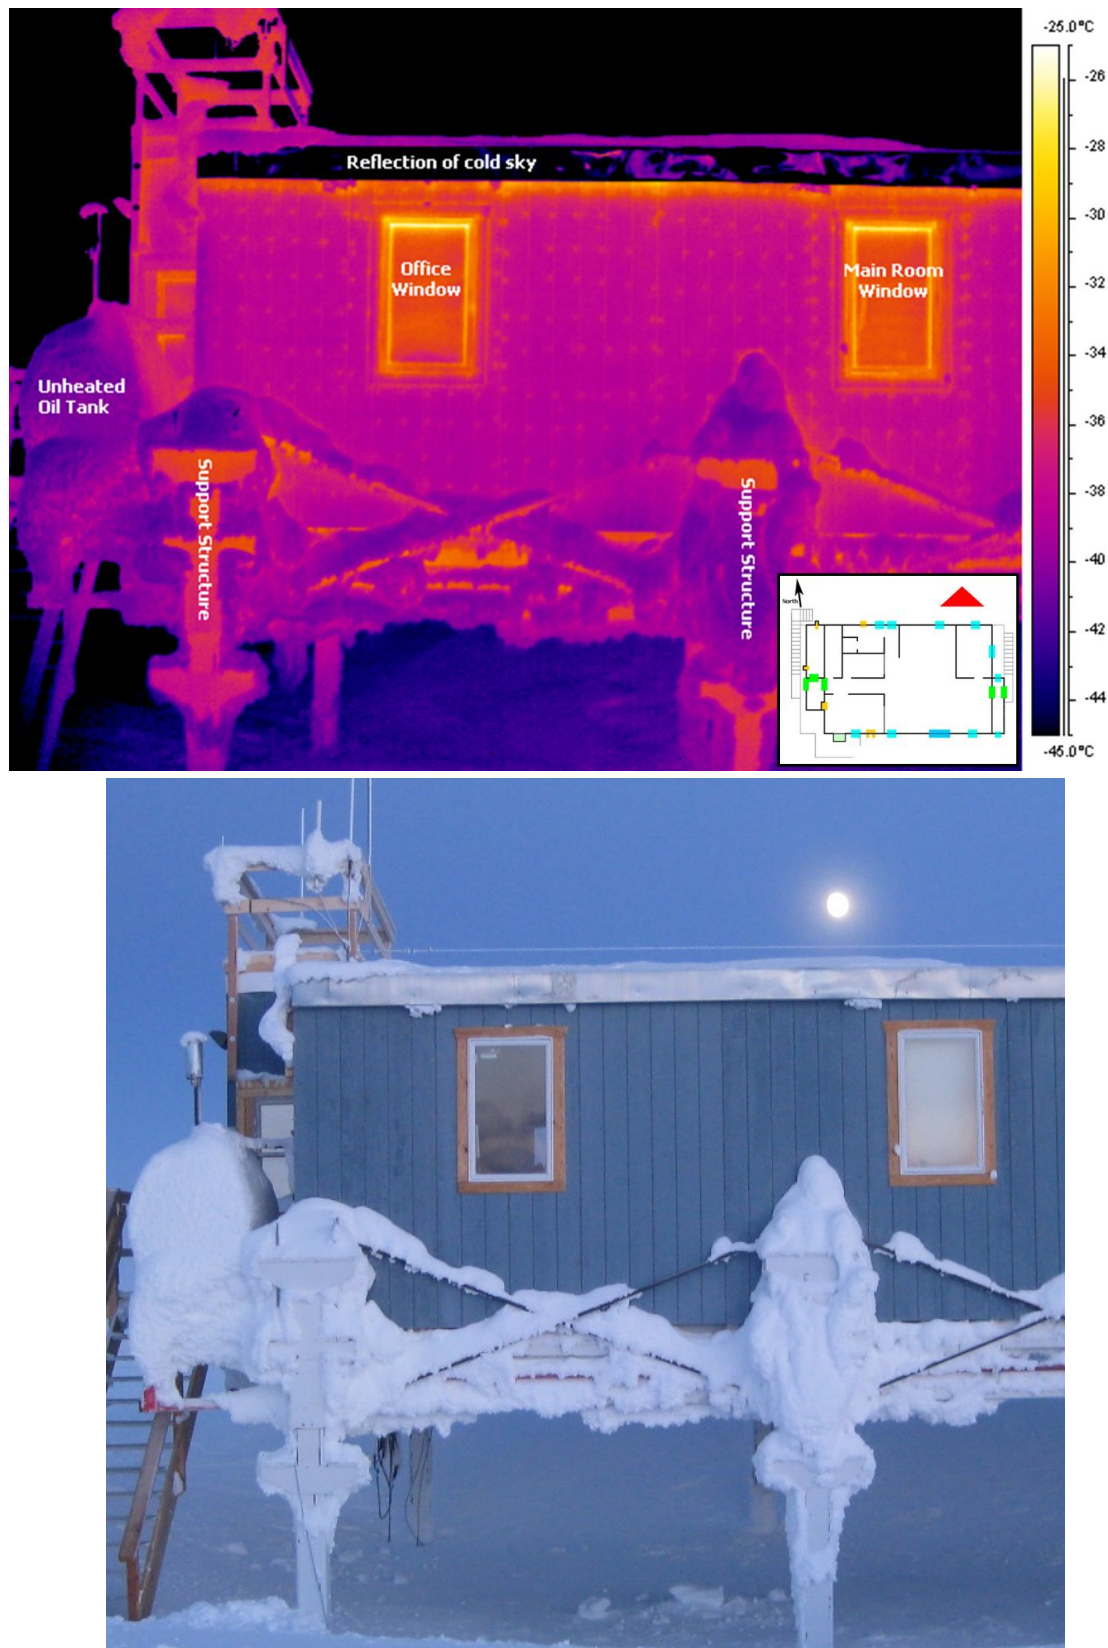
The images at the eastern end of the north wall, as shown in **View 3** (Fig. 16), include the office window (left) and the main room window (right). Both windows are wood frame, double-pane casement. The fuel tank on the deck is the round, snow-covered object located on the far left in the image. Consistent with the windows in **View 2**, the headers at the top of both windows have a brighter area in the IR image, indicating heat loss, and there is more heat loss through the window pane compared to the wall. Heat loss at the top of a window is common as this is a discontinuity within the wall system, and there may be a gap between the wall and the window frame.

Figure 16. View 3 showing location (inset), thermal, and visual image of the eastern end of the North exterior wall in the vicinity of the office and main room.

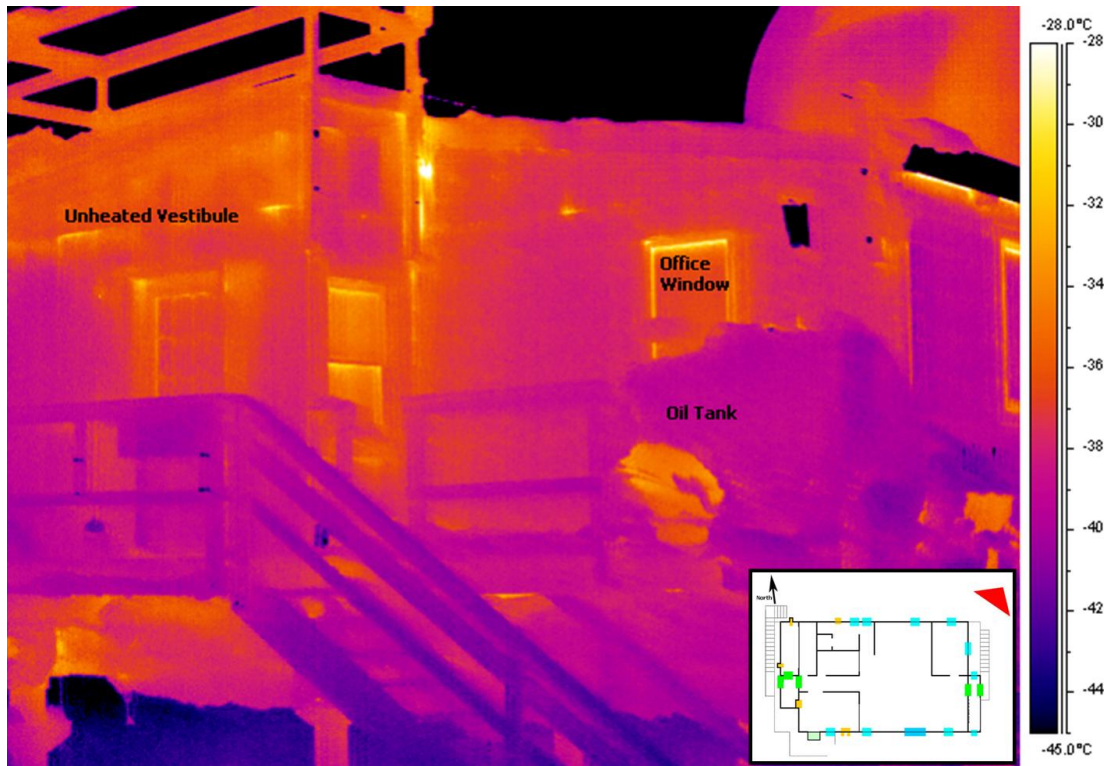
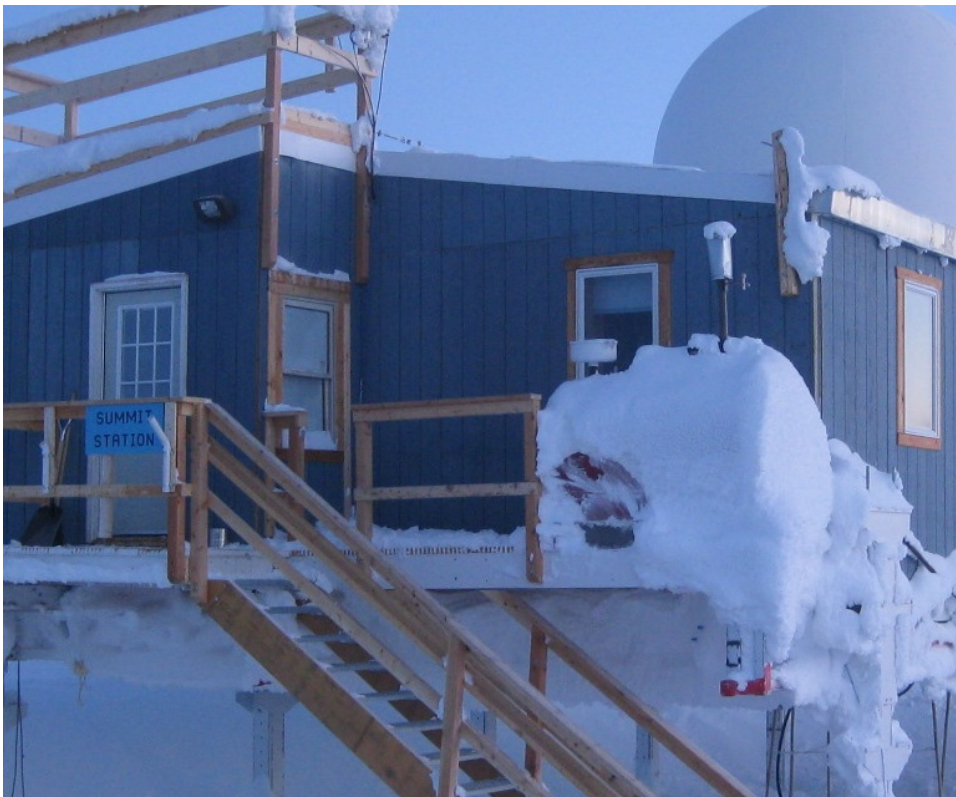
horizontal line above the doorway in the vestibule shows heat loss through the seam where the ends of the T-111 sheathing butt together. This is also clearly visible in the next IR image.

Figure 17. View 4 showing location (inset), thermal, and visual image of the northeastern corner including the office and eastern unheated vestibule.

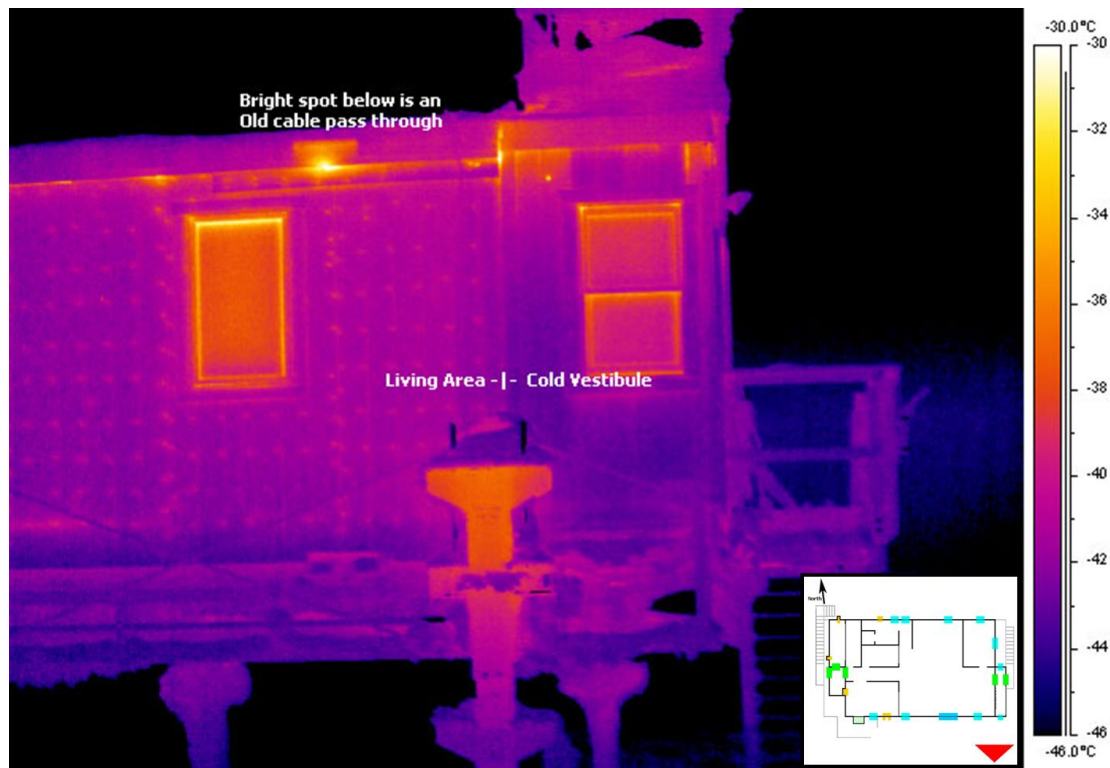
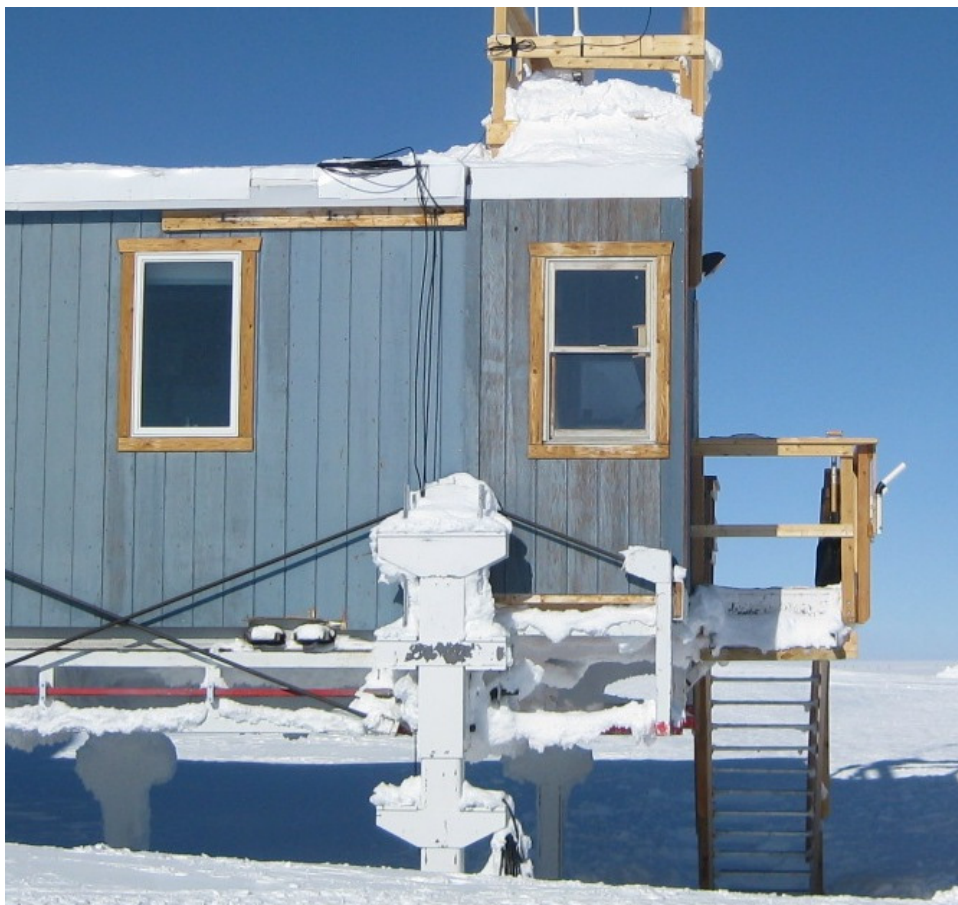
Along the eave are two bright spots showing heat loss from penetrations where previous instrumentation was mounted to the exterior (to the right of the main room window) and existing cables' pass-through to the roof (at the common wall between the main room and vestibule). The area on the right was sealed from the interior prior to the ERDC-CRREL field visit. Re-insulating the empty cavity through the wall should be considered to completely seal the opening and reduce heat loss. Designated cable conduits through the building envelope should be considered to decrease the number of penetrations for cables. This also ensures that the opening can be properly insulated.

Figure 19. View 7 showing location (inset), thermal, and visual image of the eastern end of the South exterior wall in the vicinity of the main room and east vestibule.

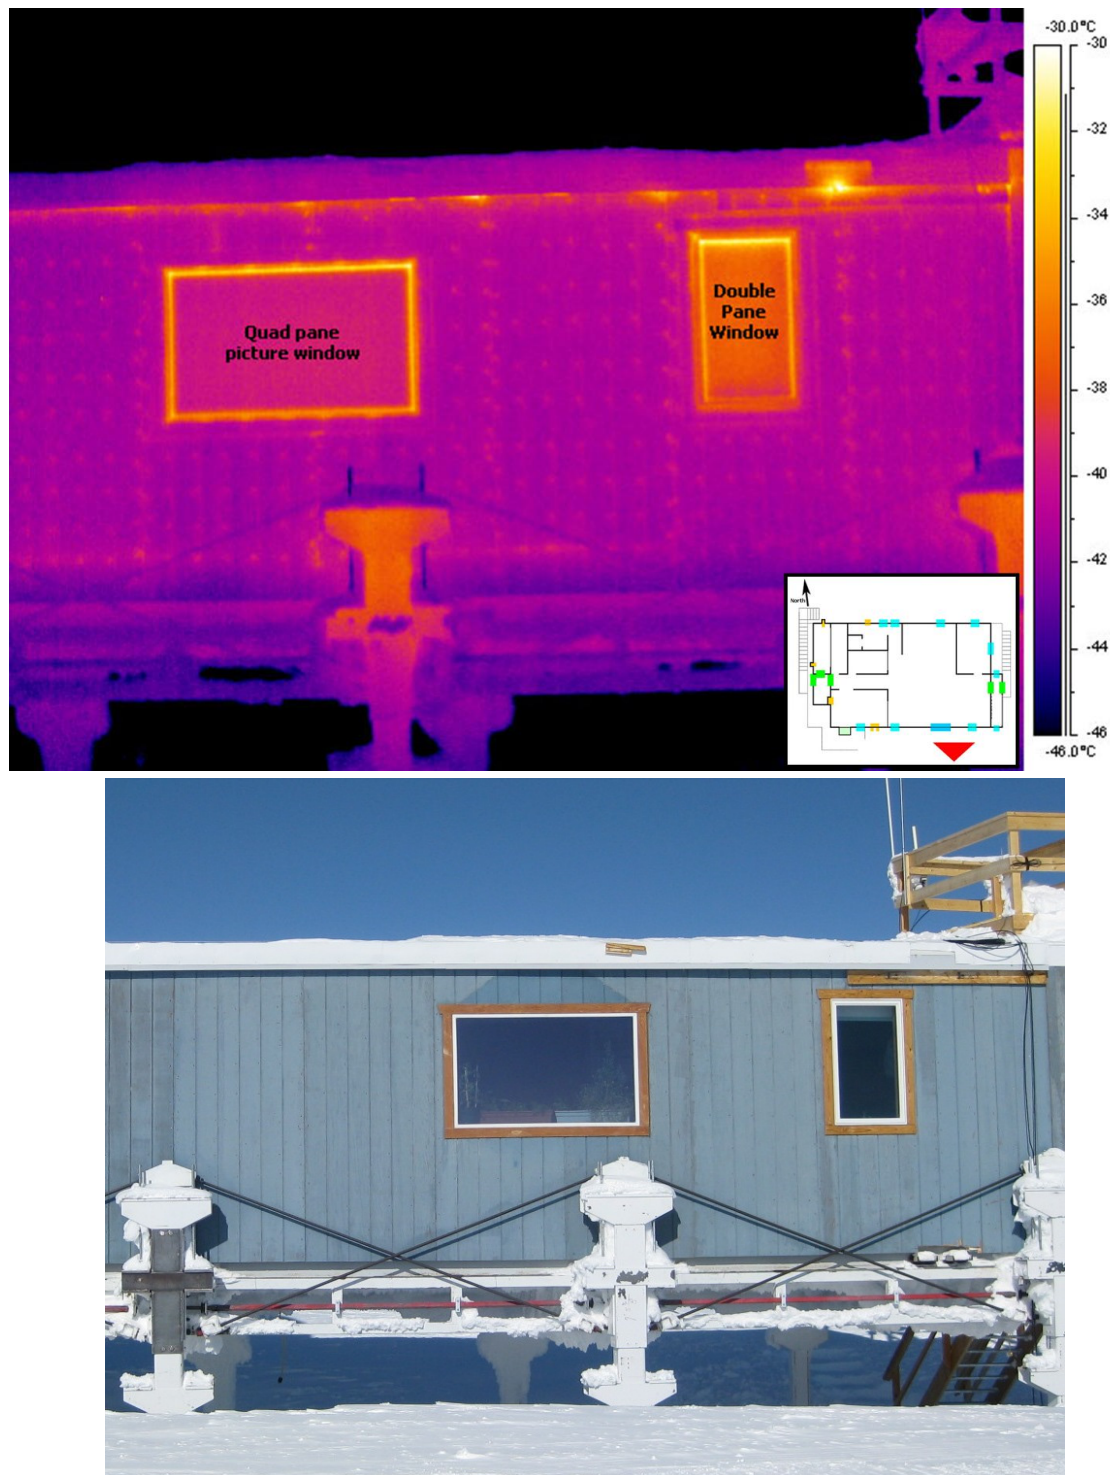
Both windows are the same type as the other casement windows previously mentioned and show similar characteristics in the IR image, with heat loss at the window header. The window on the right in the main room shows additional heat loss, and has about a 5°C temperature difference at the four bright spots under the window. This heat loss may be associated with the installation of the window, possibly ascribable to the counter on the interior that blocks the very bottom portion, or degradation of the window over time from moisture.

Figure 20. View 8 showing location (inset), thermal, and visual image of the South exterior wall in the vicinity of the main room.

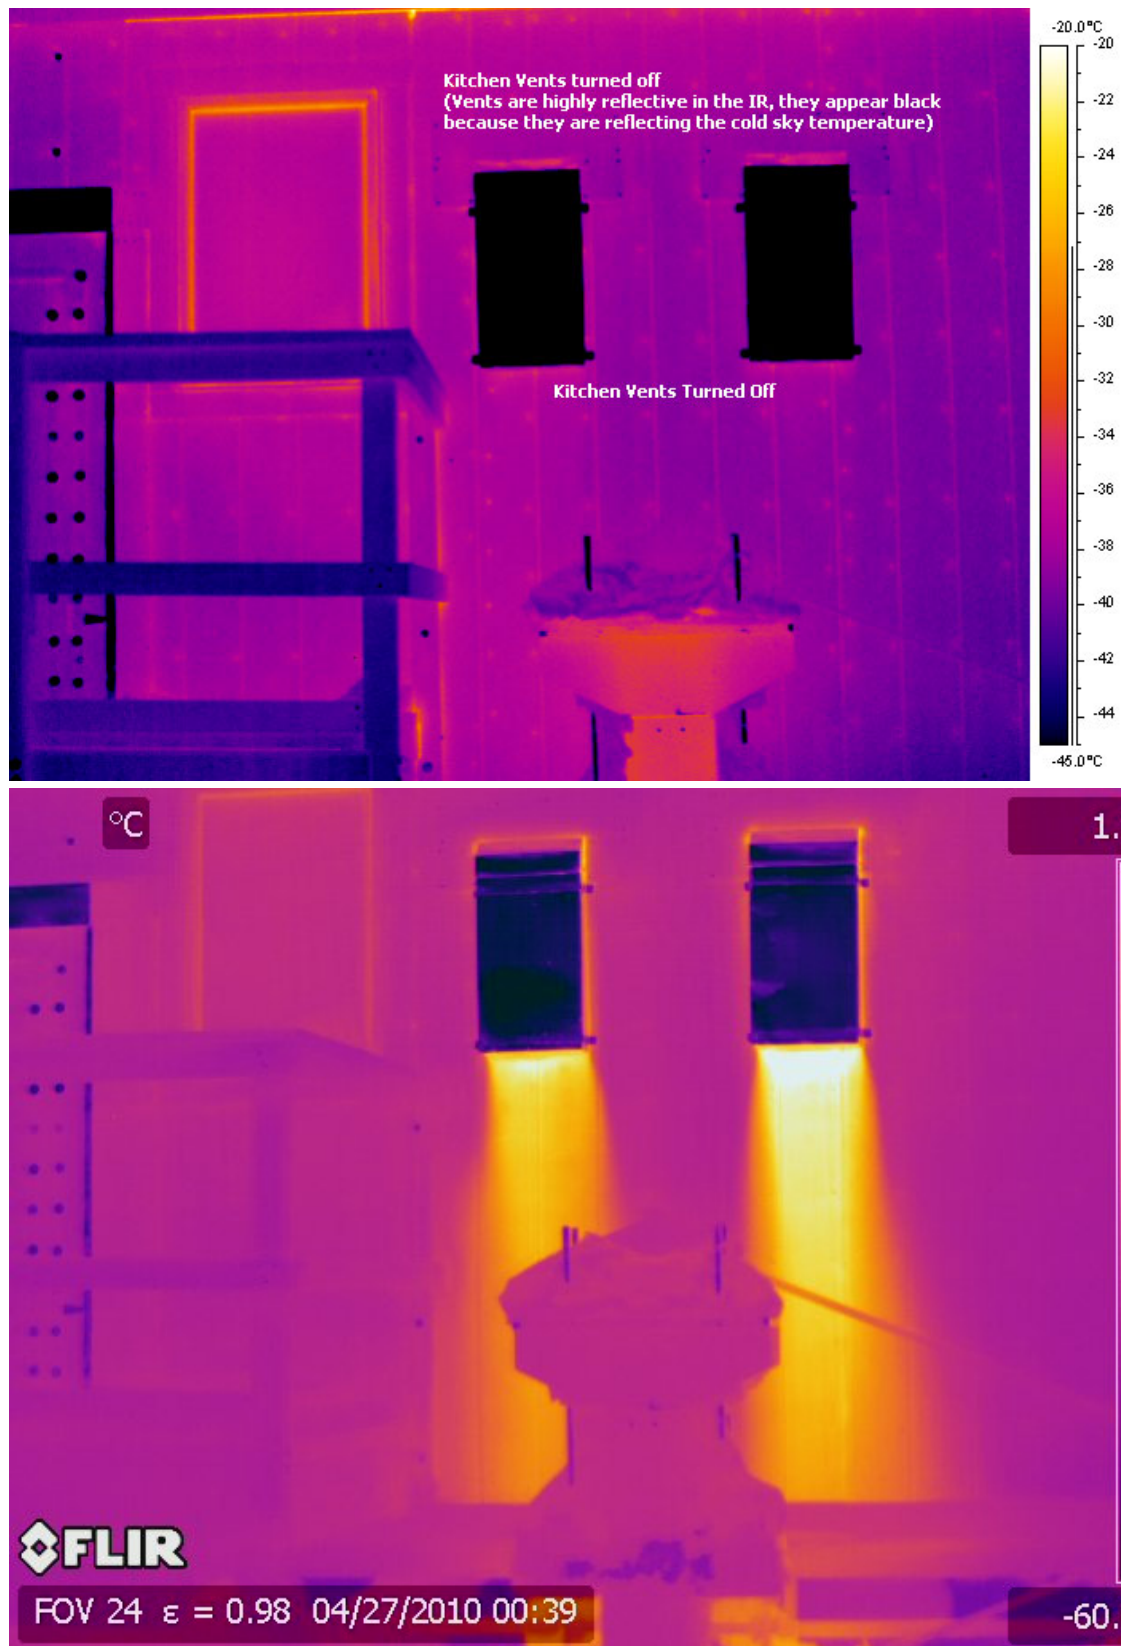
IR imagery taken from the outside of the Big House shows the impact of stove vents expelling warm air to the outside. Conversely, when the vents are not in use, cold air infiltrates the building through the vents.

Figure 22. Thermal image taken before and during stove vent operation.

- Continue to periodically locate and seal up areas where cold air infiltrates into the building.
- Prevent cold air leakage into the building via the stove vents, so appropriate dampers for them should be explored.

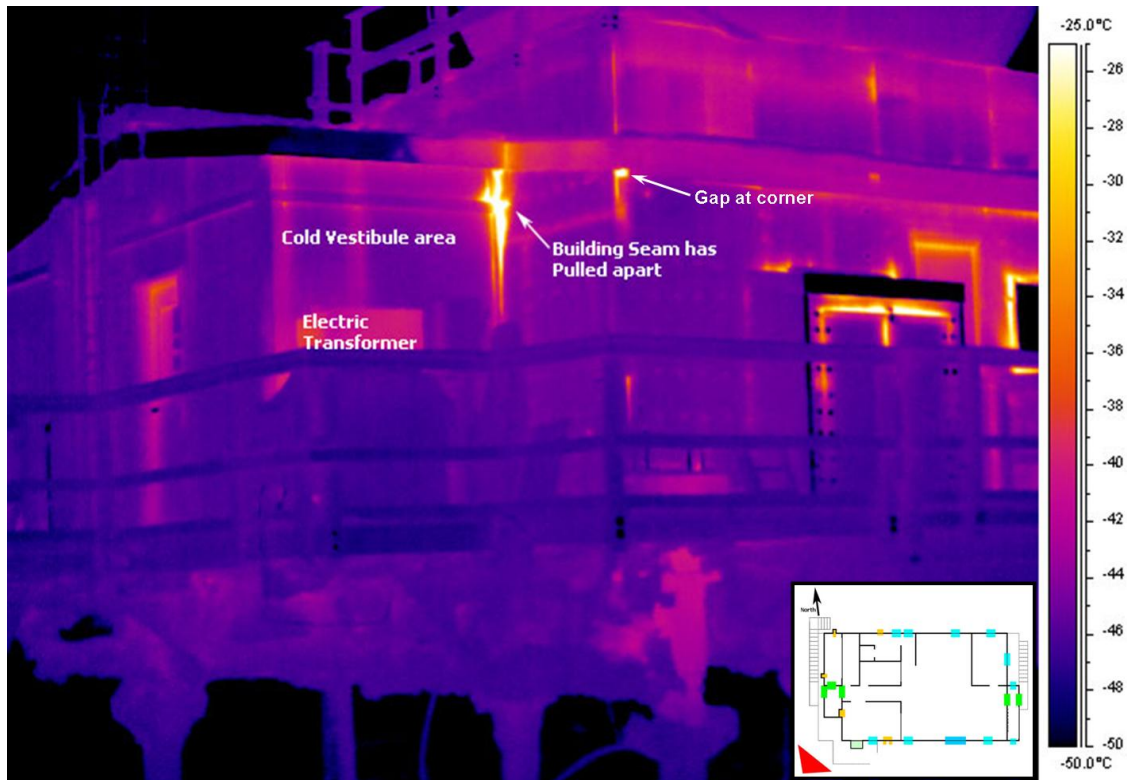
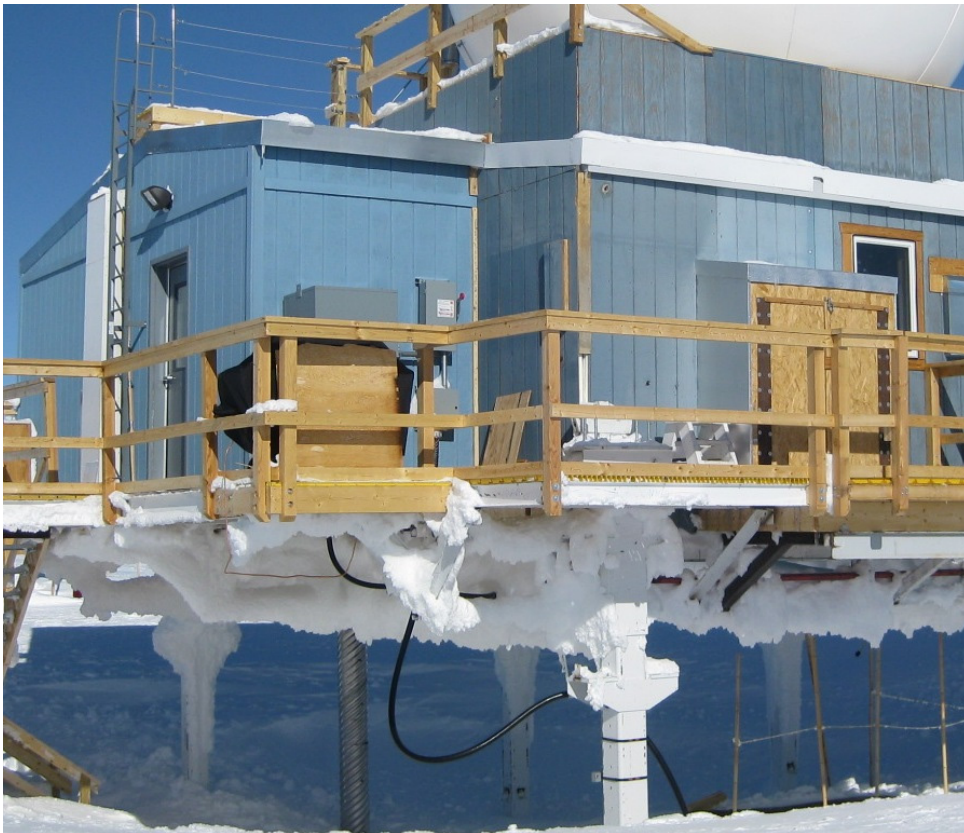
The southwestern corner of the building is shown in **View 12** (Fig. 24) where the west unheated vestibule connects to the main building. The southern portion of the vestibule contains shelving for dry goods and also houses the 600- × 600-mm fresh air intake into the kitchen. The very bright spot at the interface between the main building and the vestibule is a gap indicating excessive heat loss. Further to the right, at the corner of the main building, the bright spot there is from a gap at the eave created when the building was re-sheathed (Fig. 25).

Figure 24. View 12 showing location (inset), thermal, and visual image of the of the southwest corner where the west vestibule connects to the main building

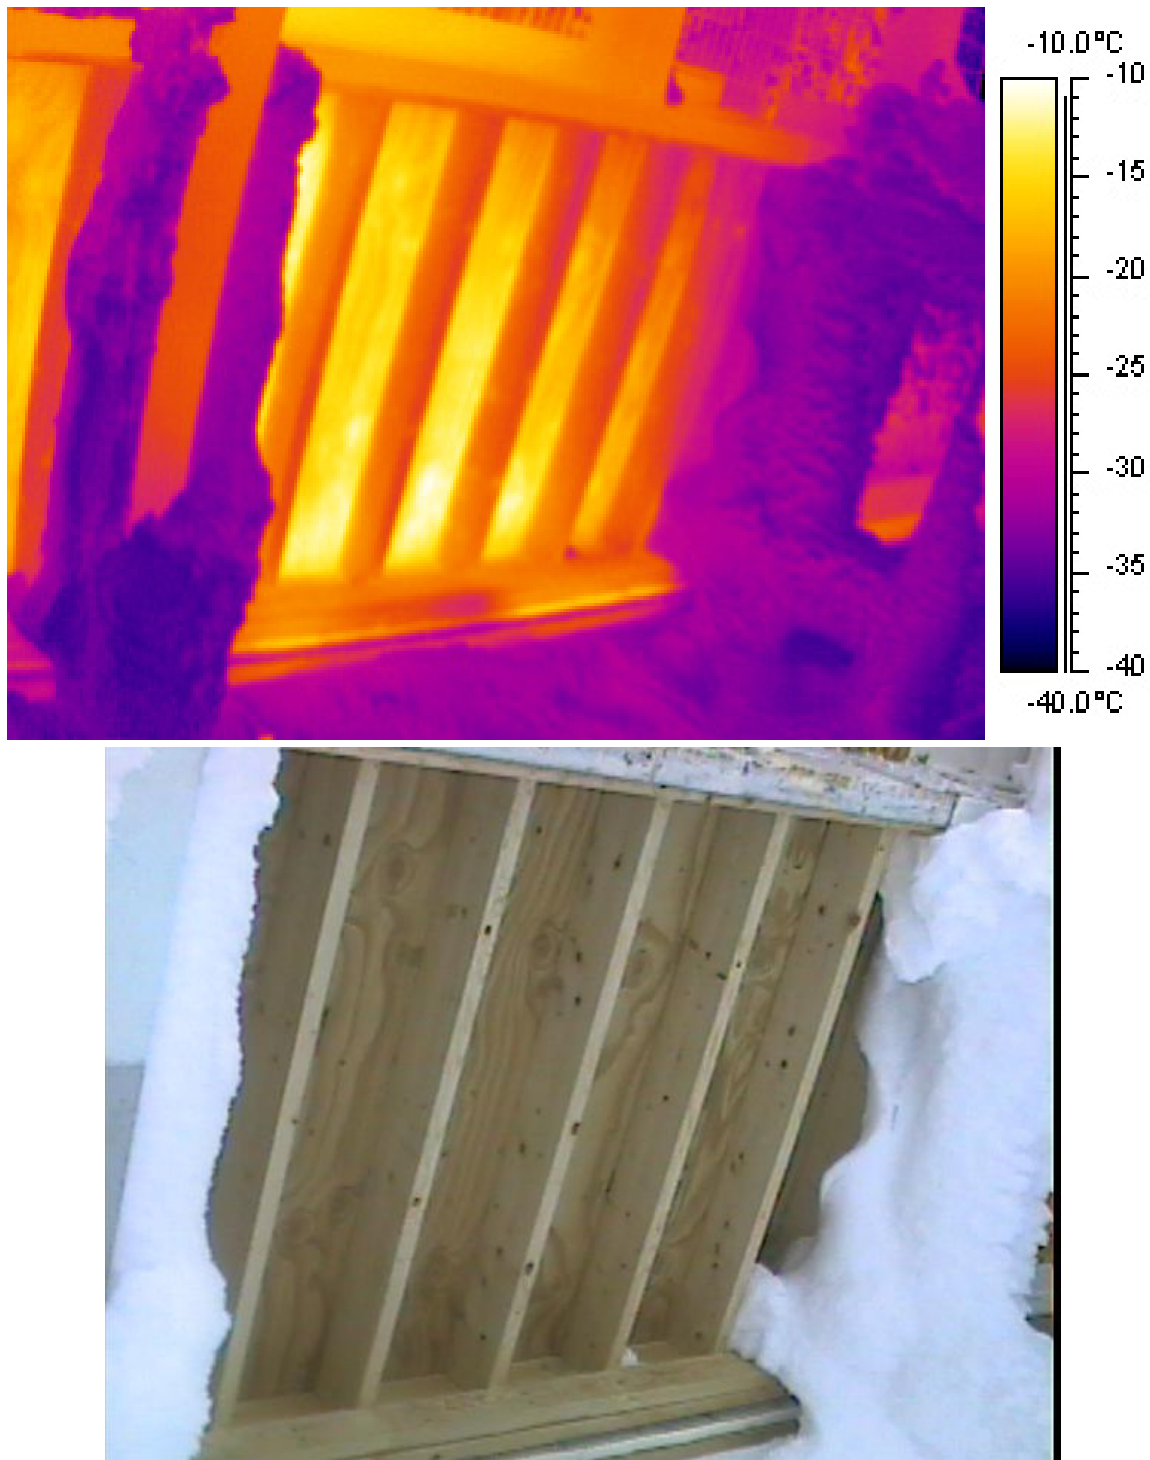
Figure 29. View showing thermal and visual image of heat loss through base of unheated eastern vestibule.

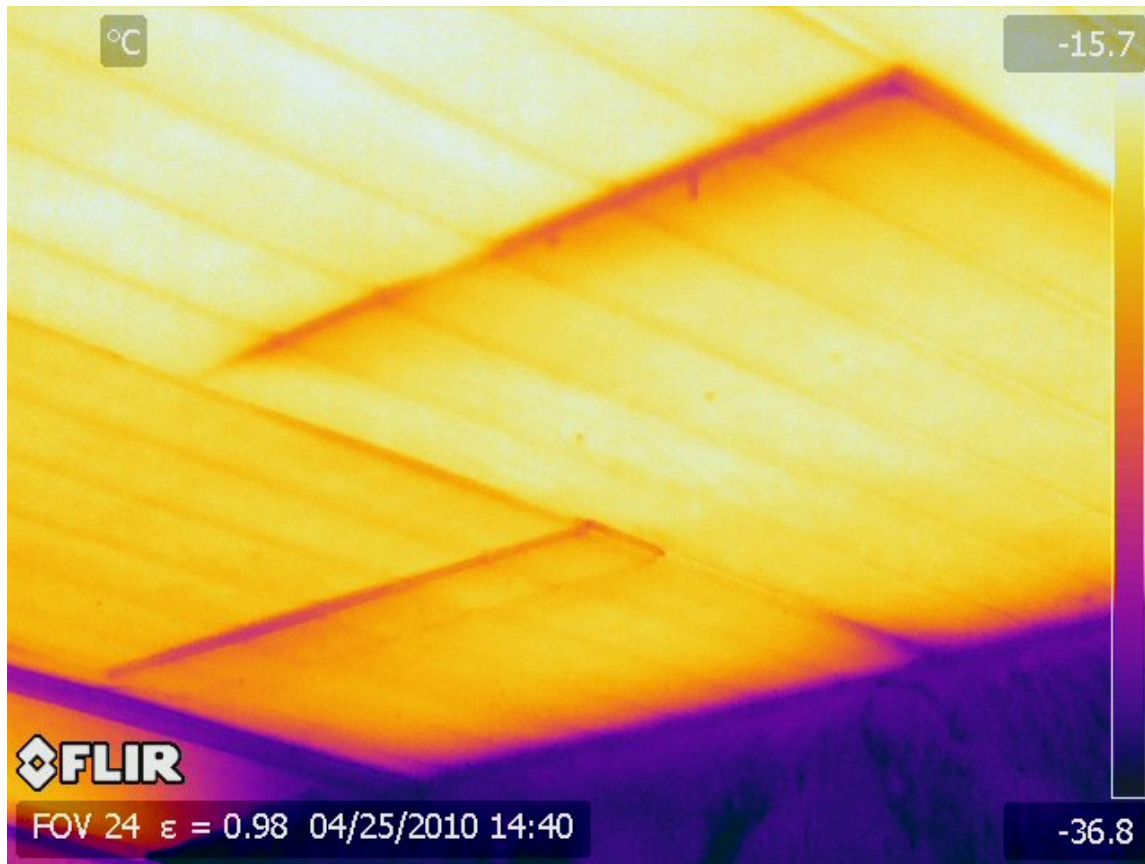
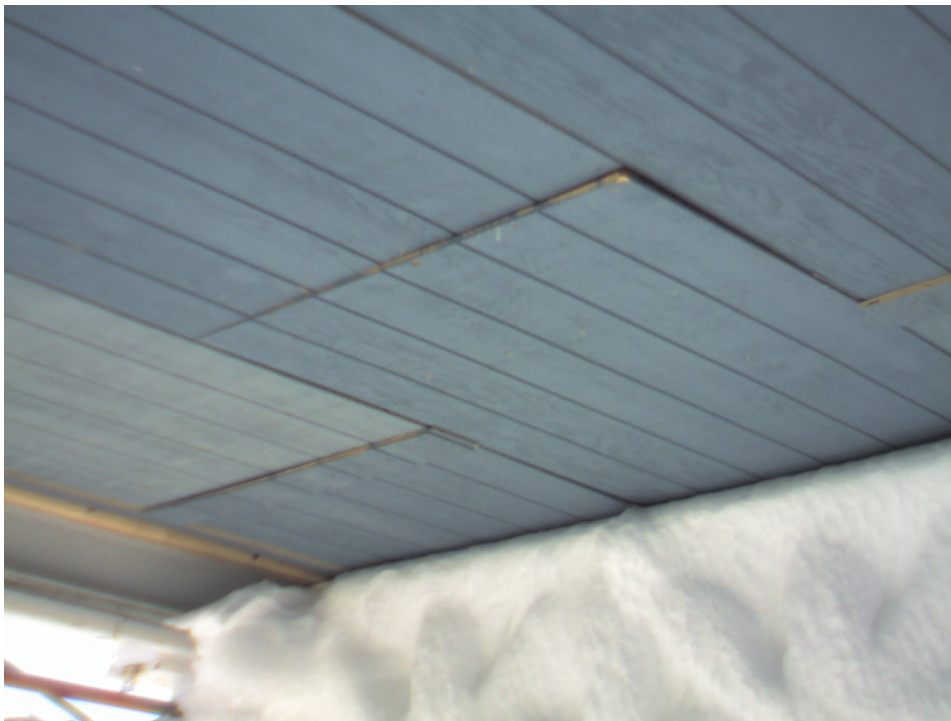
The IR imagery of the exterior base of the structure did not show significant heat loss through the floor. Other than open active vents, the blocked-off vent in the floor of the mechanical room was the only bright spot in the IR imagery. Several pieces of loose sheathing on the underside of the building should be reattached.

Figure 30. View showing thermal and visual image of unsecured sheathing on base of building.

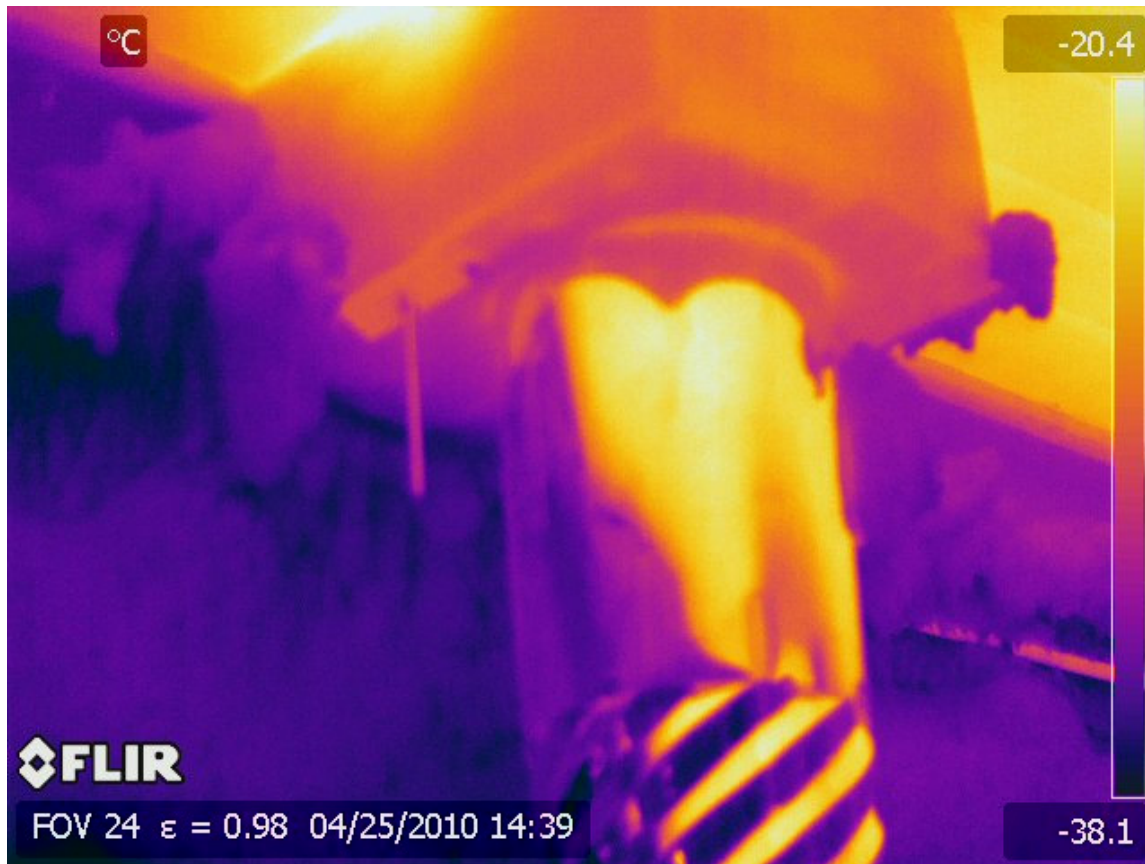
Lastly, Figures 31 and 32 show IR and visual images of the sewer outfall pipe and the opening of the fresh air intake vent in the kitchen, respectively. The sewer outfall pipe shows some heat loss at the interface between the housing around the pipe and the base of the building. Likewise, there is heat loss from the kitchen through the air intake vent.

Figure 31. Base of the building, IR and visual images of the sewer outfall pipe.
